**ASSEMBLY STANDING COMMITTEE  
COMMITTEE OF THE WHOLE  
THE CITY AND BOROUGH OF JUNEAU, ALASKA**

**A. Landslide Hazard Mapping**

**SUBJECT:** Landslide and Avalanche Hazard Maps

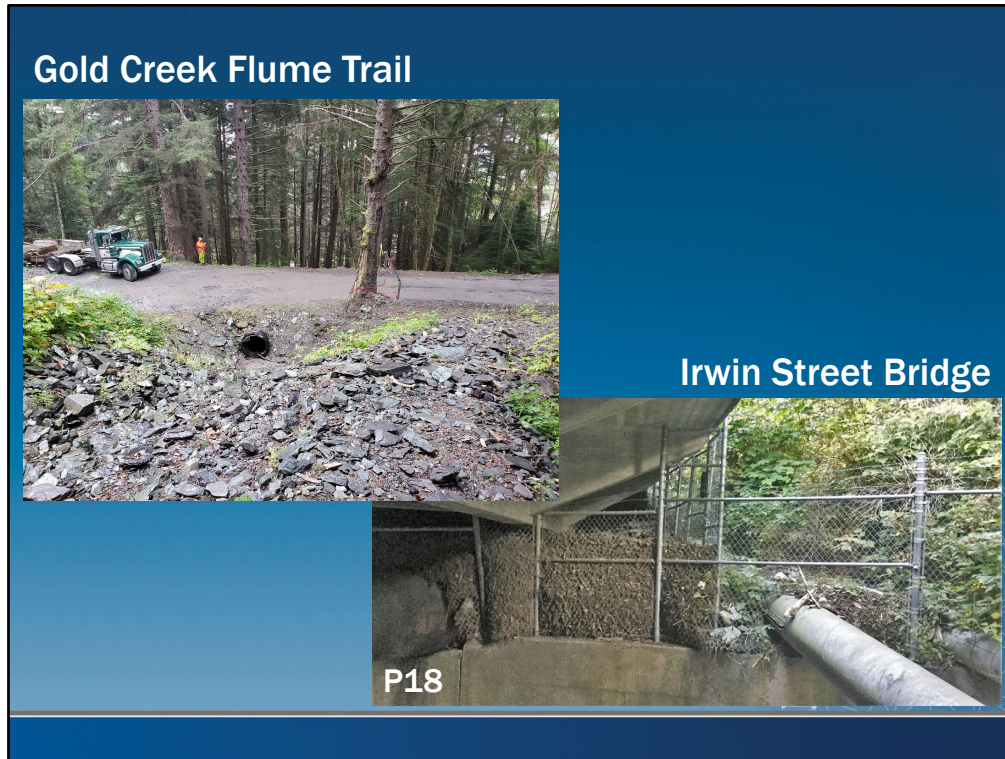
Here's the Bathe Creek debris flow gully – the top photo is looking down towards the Gold Creek Flume Trail. There's a lot of fresh debris in this gully and scarring on the tree beside the road. In the bottom photo, debris flow deposits from the main gully at Bathe Creek are visible under the Irwin Street bridge at Gold Creek.

As we saw on the map, there are two big gullies alongside the Bathe Creek debris-flow deposition cone, one on each side of the Hermit/Rheinhardt residential area. The upper east end of Evergreen Avenue is near the top of the cone, and Irwin Street is at the bottom. Smaller gullies are also visible above Hermit Street within the cone. Any diversion of the debris at Evergreen or the Gold Creek Flume Trailhead could result in debris flowing through the residential area.

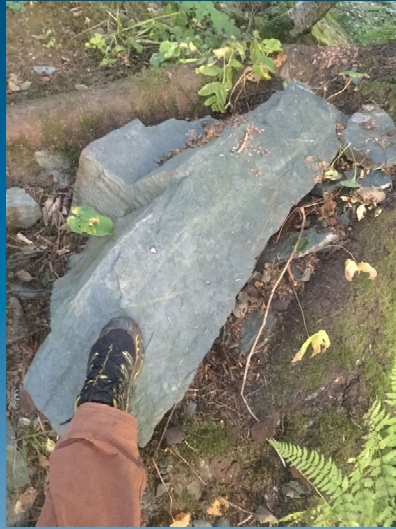
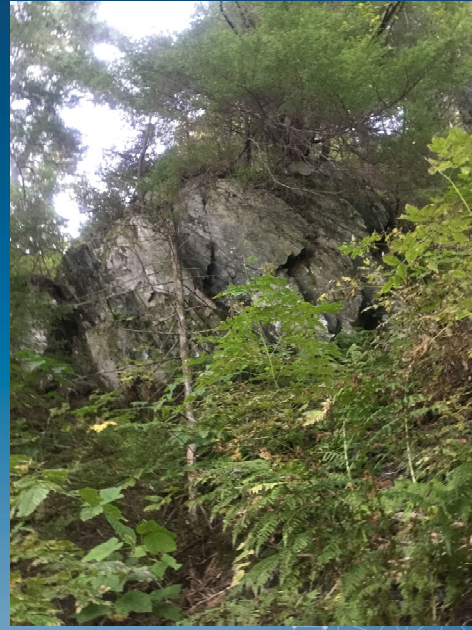
## Starr Hill - Rockfall

Sometimes, we discover exactly what we expected from the maps. Other times, we discover that there are even *more* landslide features that couldn't be seen on the air photos, like rockfall that doesn't destroy the trees, or very narrow gullies or slide paths hidden by the trees, such as on the slopes above parts of Starr Hill. In the field, we try to collect enough information to confirm or correct the mapping.

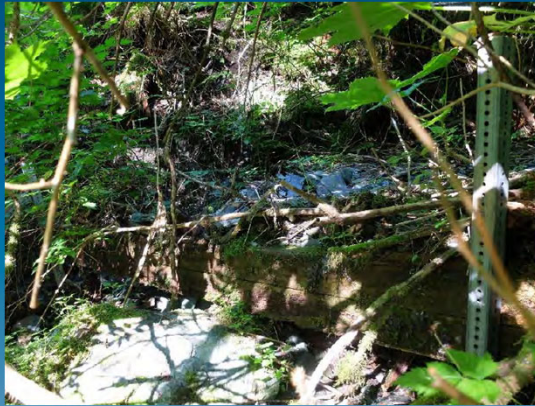
## G000 Park Path – Starr Hill

Here are a couple of mitigation structures built by homeowners living below the G000 Park debris flow path above Starr Hill. Thank you to nearby residents for that photo on the left. That structure appears to be full of debris already. The structure on the right has captured debris material from one or possibly two events. Depending on the size of the next debris flow, these structures could retain a little more debris or, instead, they could collapse, be overrun by debris, or even be completely scoured out by a larger debris flow originating further up the gully. The homeowners currently living below this debris flow path reported that some of the structures need repair or replacement. Also of concern, the creek in this gully is currently routed through a culvert under a house lower on the slope.
